Smoke and Dye Testing Summary

High Level Sewershed

Run Summary

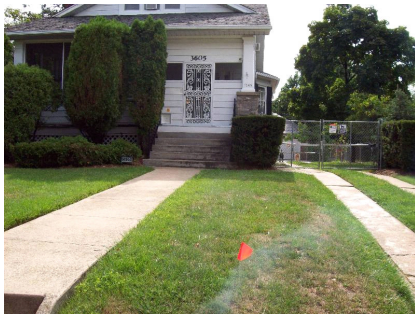
Picture \S1028-002-OB01-P01.jpg

Source Cleanout

Location Yard - front

Comments Smoke from cleanout in front yard. 3605 Callaway Ave.
